Manhole Inspection Summary

Manhole # S35QQ_018MH

Insp Date: **1/22/07 9:41 AM**

Location Address: **104 25TH ST**

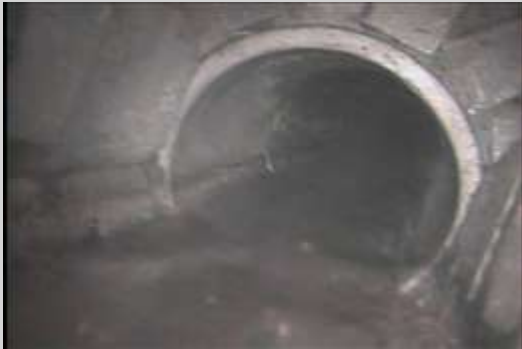
8 in. Circular Gravity Sewer Pipe Out @ 12 O'Clock

Pipe Material: **Clay** ☐ Pipe Lined

Invert Depth: **9.00** (ft.) Flow Characteristics: **Slow**

Deposits: ☒ None ☐ Mud ☐ Sludge ☐ Debris ☐ Grease

Infiltration: **None** Pipe Seal Cond: **Unknown**

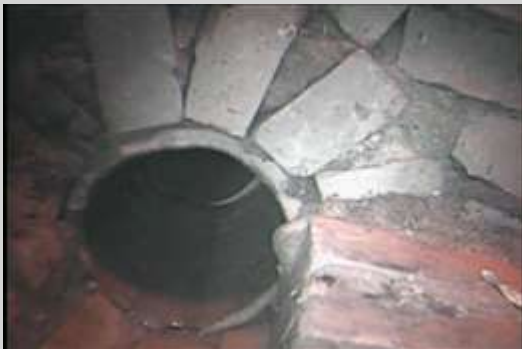
8 in. Circular Gravity Sewer Pipe In @ 3 O'Clock

Pipe Material: **Clay** ☐ Pipe Lined

Invert Depth: **8.40** (ft.) Flow Characteristics: **Slow**

Deposits: ☒ None ☐ Mud ☐ Sludge ☐ Debris ☐ Grease

Infiltration: **None** Pipe Seal Cond: **Unknown**

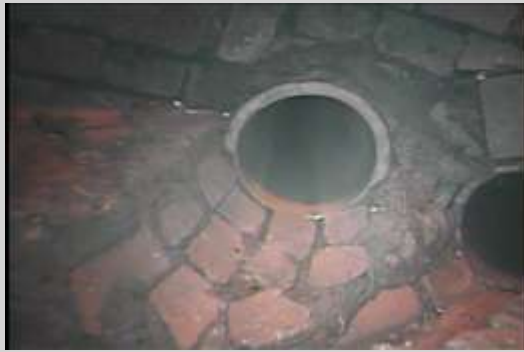
6 in. Circular Gravity Sewer

Pipe Material: **Clay** ☐ Pipe Lined

Infiltration: **None**
